# Hazard Alert

## Roof Truss Collapse

### Hazard Summary

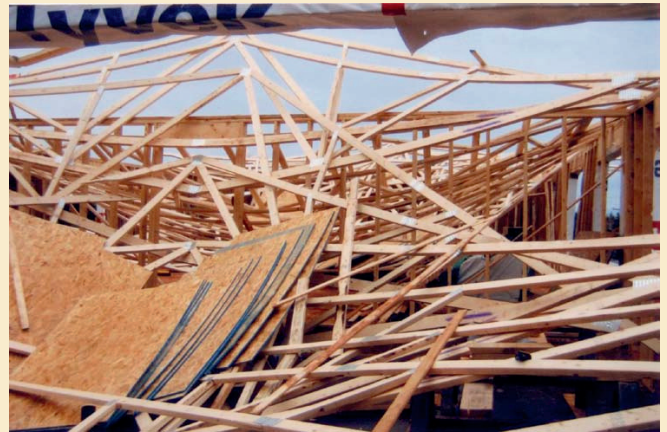
Two workers were injured as a result of a roof truss collapse during the construction of a house. The truss system had been installed and braced, and ready for sheathing. Soon after several piles of sheathing had been loaded onto the truss system, it became clear that the weight was more than the individual trusses were designed to support. The loaded trusses began to roll horizontally, collapsing the entire system and causing injuries to the workers.

The manufacturer's recommendations were not followed when the individual trusses were overloaded with construction material that weighed more than the trusses could support.

- Employers must make sure that workers understand and follow procedures supplied by the truss manufacturer on handling, erecting, positioning and bracing trusses
- Employers must make sure that truss erection is directed by a "competent" person under Occupation Health and Safety Regulations, who is appropriately qualified based on training, experience, and knowledge of the Act and Regulations
- Employers must make sure that trusses are properly braced to maintain structural capacity and stability
